Manhole Inspection Summary

Manhole # S41AA_016MH

Insp Date: 1/30/09 1:37 PM

Location Address: **rear 1509 lester morten ct**

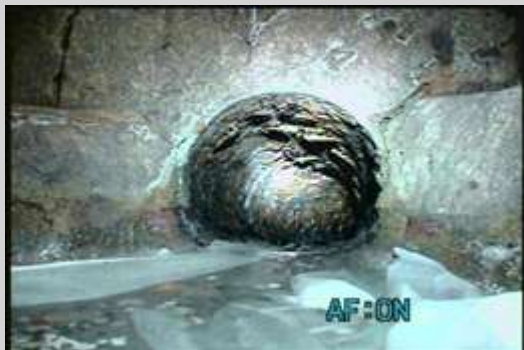
12 O'Clock Outflow

6 in. Circular Gravity Sewer
Pipe Out @ 12 O'Clock

Pipe Material: **Clay** ☐ Pipe Lined

Invert Depth: **5.46** (ft.) Flow Characteristics: **Fast**

Deposits: ☒ None ☐ Mud ☐ Sludge ☐ Debris ☐ Grease

Infiltration: **None**

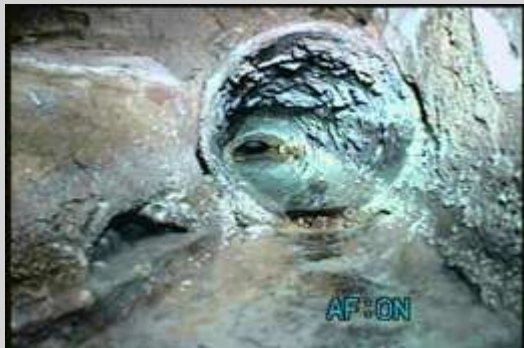
3 O'Clock Inflow

4 in. Circular Gravity Sewer
Pipe In @ 3 O'Clock

Pipe Material: **Clay** ☐ Pipe Lined

Invert Depth: **5.38** (ft.) Flow Characteristics: **Fast**

Deposits: ☒ None ☐ Mud ☐ Sludge ☐ Debris ☐ Grease

Infiltration: **None**

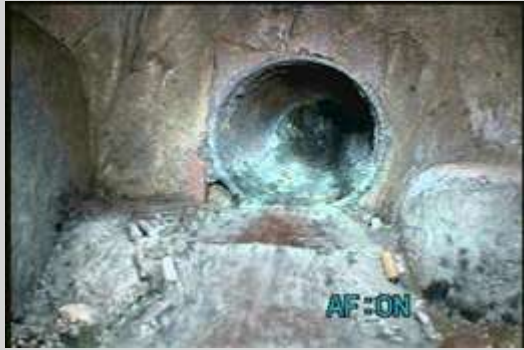
9 O'Clock Inflow

6 in. Circular Gravity Sewer
Pipe In @ 9 O'Clock

Pipe Material: **Clay** ☐ Pipe Lined

Infiltration: **None** Pipe Seal Cond: **Unknown**
